## **APPENDIX 5. Worksites in Focus**

## Drive-Thru Classroom Self-Guided Tour

## Potter County Horseshoe Road

## Fulton County Dutch Corner Road

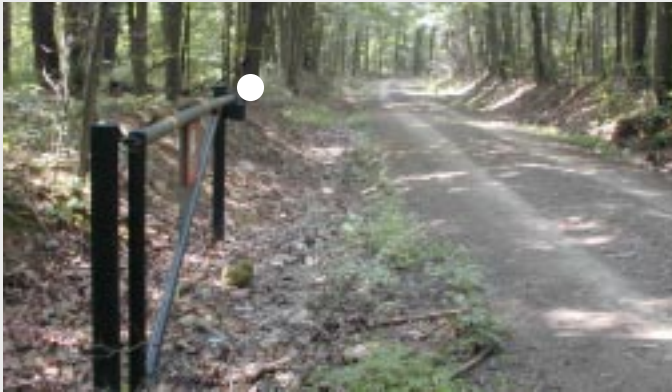
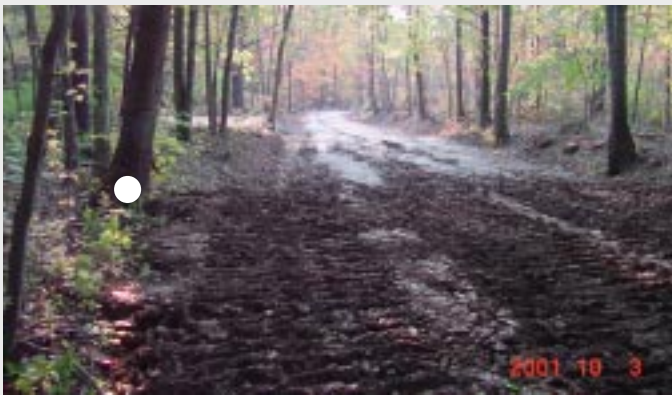
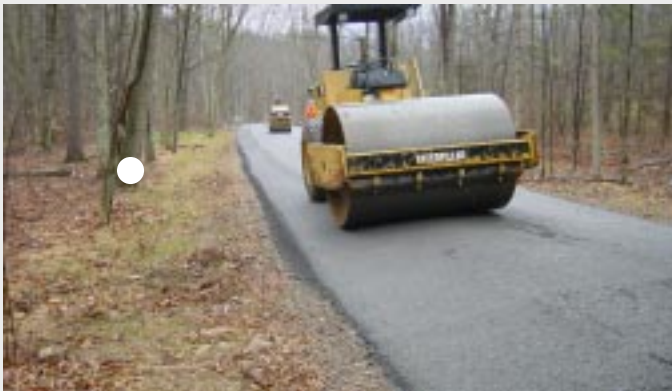
## raising the road profile before, during & after

Because the road was lower than the surrounding terrain, rainfall and runoff were captured and concentrated in the roadway, gaining energy and eroding road surface and bank materials. This concentrated flow exited the road with tremendous force, directly into the stream. The stream, consistently inundated with a high-velocity input of sediment-laden water, was eventually incised to the point that it was totally disconnected from its floodplain.

The road profile was raised to eliminate ditches and allow road runoff to flow gently from the road surface into the surrounding porous forest soils. One particularly problematic section of road was shifted uphill, away from the stream, to protect an already damaged and fragile stream reach from further harm. Selective thinning of the tree canopy allows the road to dry out while promoting healthy forest growth patterns.

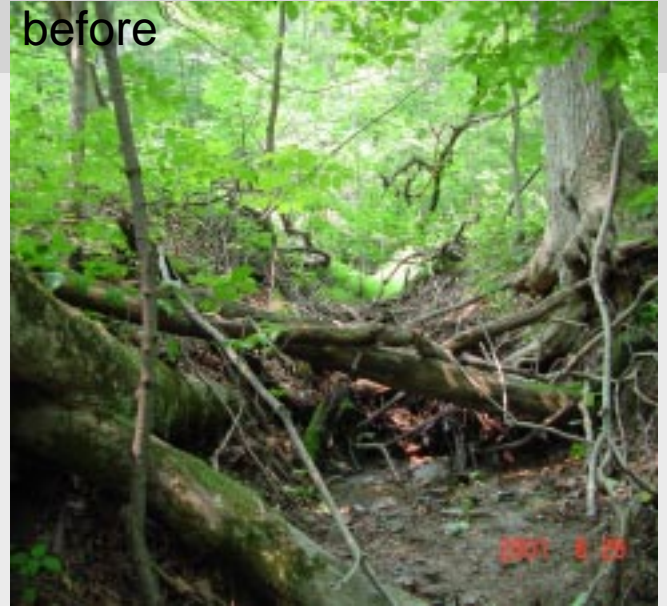
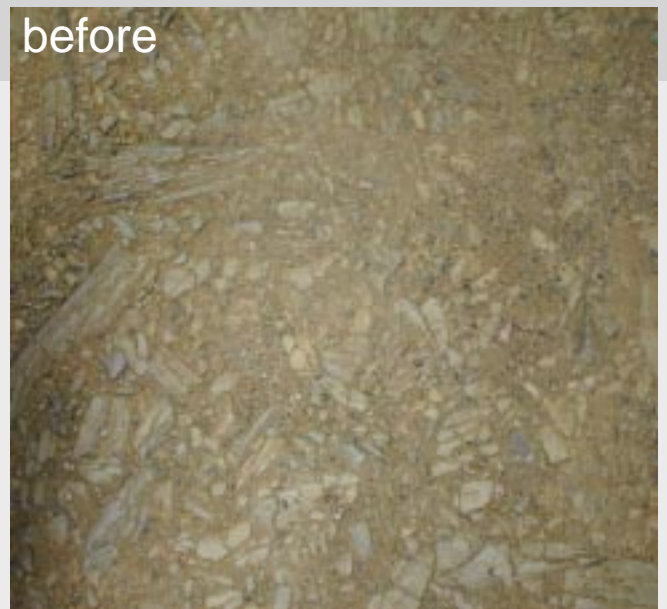
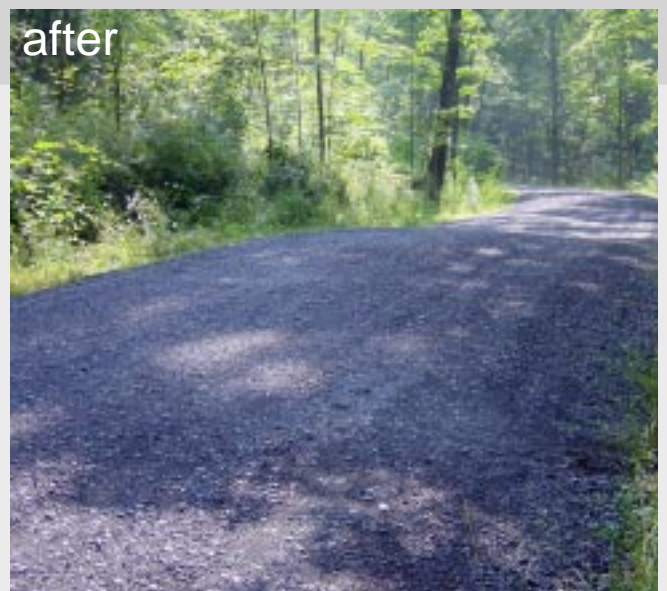
The bank-run shale used on the previous road surface had pieces in it that were too large for available grading machines to work into a drivable surface. Left un-graded, the road deteriorated. Shale has two other disadvantages. It "slacks," or breaks down into silt or clay soil particles when exposed to air, and it does not resist the abrasion of traffic well enough to be rated as a suitable road surface material. Clay and silt are the soil types most prone to make dust and sediment. The Driving Surface Aggregate visible now is a specially formulated mixture of abrasion resistant limestone. Contrast this surface with that of nearby off-site locations.

The pipe here was installed at an elevation high enough to allow the pipeflow to discharge at natural ground level. In order to get the required 12" of cover over the plastic pipe, a grade break was constructed. Grade breaks are inexpensive to build, easy to maintain, and serve several purposes. The additional road material used to construct the grade break provides cover for the pipe, slows traffic, and acts to divert water flowing down the road surface into the road ditch. This disruption of water flow prevents road deterioration from water movement on steep road grades and lengthens maintenance cycles.

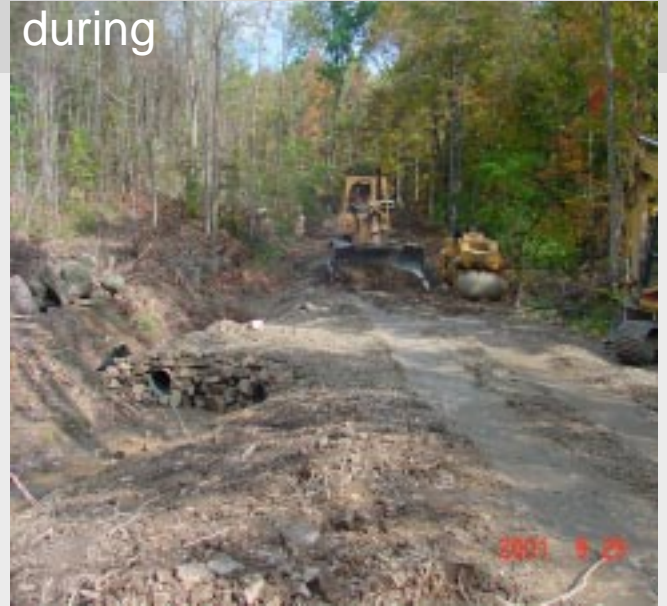
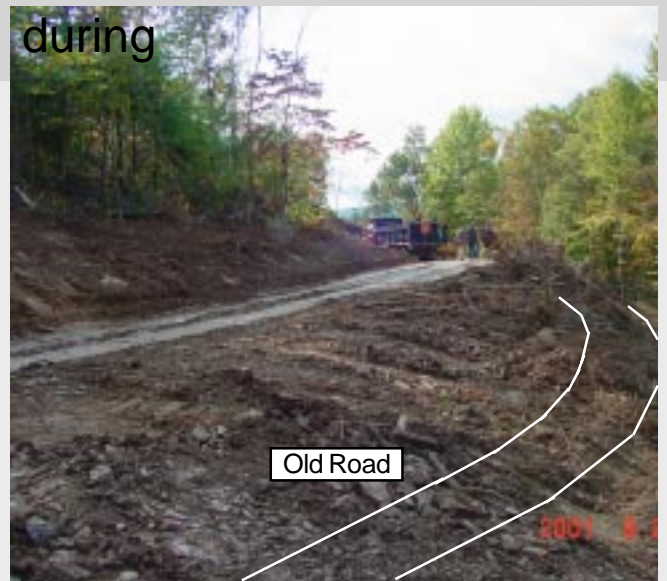
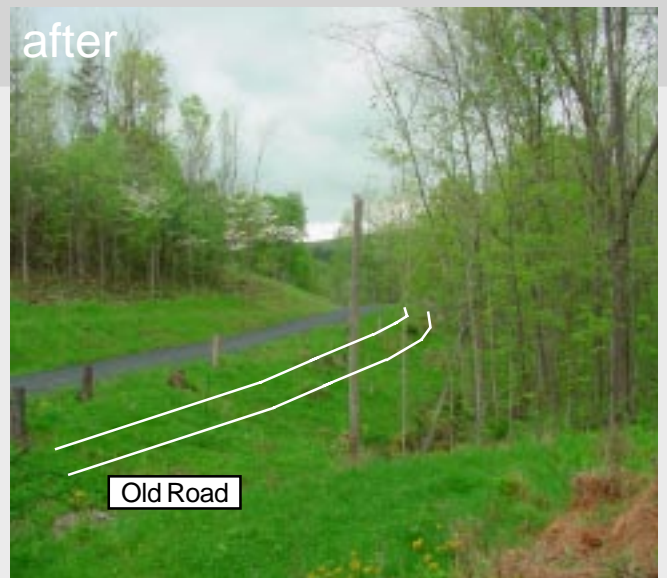
Sediment from the original road, indicated on the photo at right, flowed directly to the adjacent stream reach. The road base would eventually have failed as storm flows continued to erode the stream banks. This is a very common problem wherever roads are located too close to streams.

Contrast during your visit how growth patterns are influenced by water and leaves trapped upslope of the obstructions. As organic matter builds up from leaf litter, more water will be retained over these dry soils. In turn, the numbers of microbes and small creatures like earthworms will increase. As they do, growth capacity of this abandoned shale pit will increase.

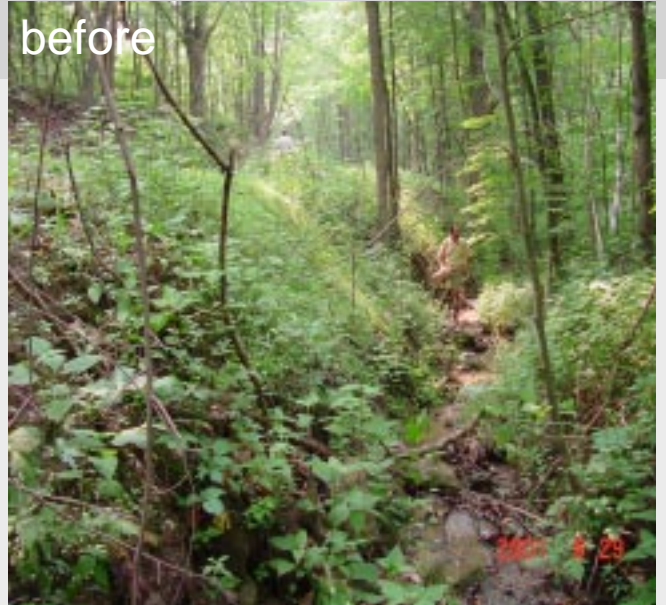
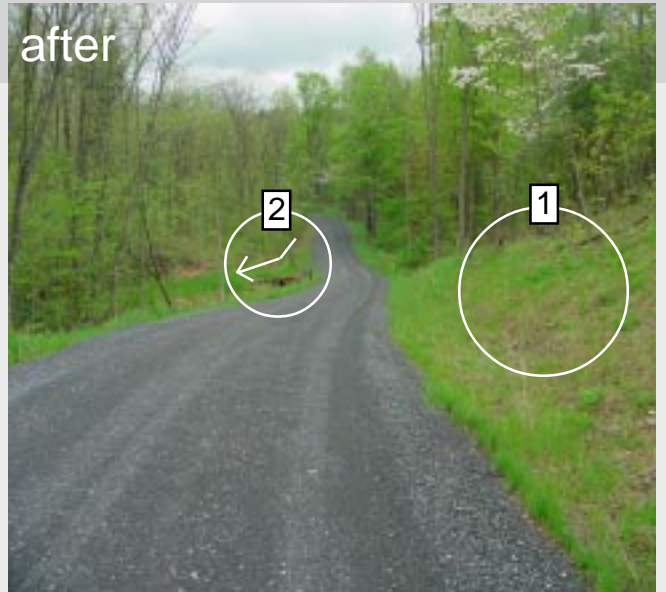
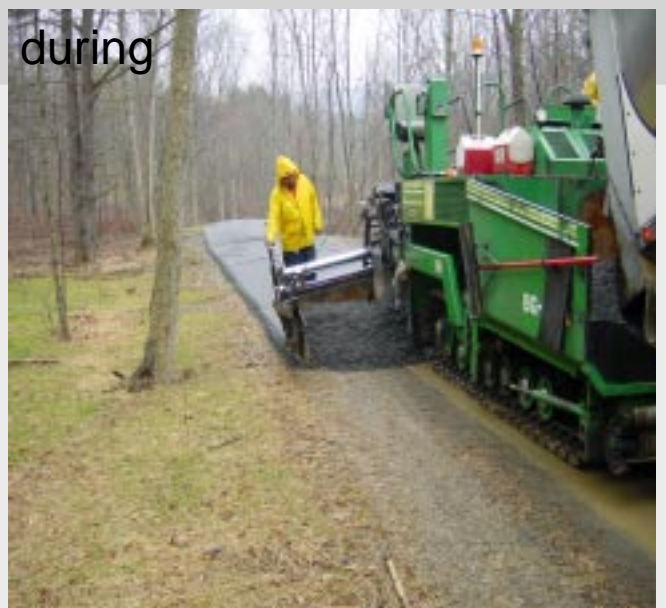
In contrast, the stream channel immediately below the road reflects the long-term effects of concentrated road drainage. Notice the severe down cutting that causes the channel to be deeper than it is wide and the complete physical separation of the stream from its floodplain.

Drainage patterns such as crown and grade breaks, visible in the surface of the road, are reflected in every layer of fill to enhance subsurface water movement under the road base. The top layer is Driving Surface Aggregate (DSA), a specially formulated abrasion resistant mixture of crushed limestone. DSA has a carefully blended size distribution from 1½" stone to fine particles small enough to pass a screen with 200 holes per square inch. The fines act to fill all voids and create strength from increased density. Placement through a paving machine to a uniform 8" depth enables compaction with fines in place. This placement method avoids aggregate separation.

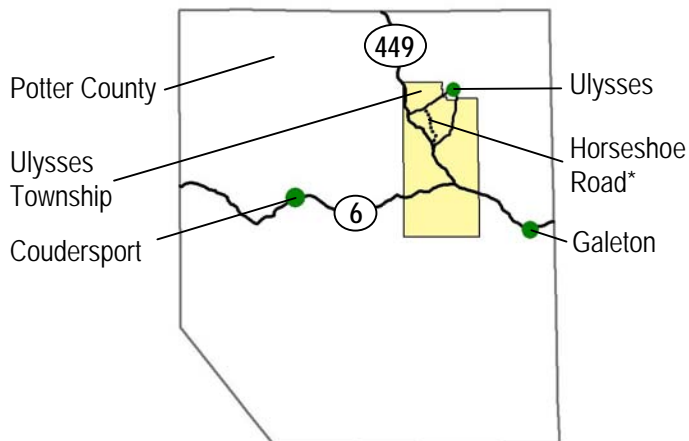
Routine maintenance operations and the wear and tear of traffic had the cumulative effect of lowering the road elevation in relation to the surrounding terrain (see photo). The resulting entrenched road trapped road drainage. Confined by the road, this water concentrated in parallel ditches and gained velocity. As the volume and velocity increased, more and more valuable road material was washed away, polluting nearby Pine Creek.

Off right-of-way (ROW) drainage input from an adjacent driveway compounded the problems on Horseshoe Road. Existing drainage structures (ditches and crosspipes) were inadequate to handle flow volumes.

Adequately addressing drainage on Horseshoe Road required an additional drainage outlet, installation of under-drain, and elevation of the road itself.

**Adequate Culvert Size:** A hydrologic & hydraulic analysis was used to determine the proper size of the culvert needed for the stream crossing. The existing 30" round concrete pipe was replaced by a 77"x 52" squash pipe. The road was raised to ensure proper cover over the new pipe.

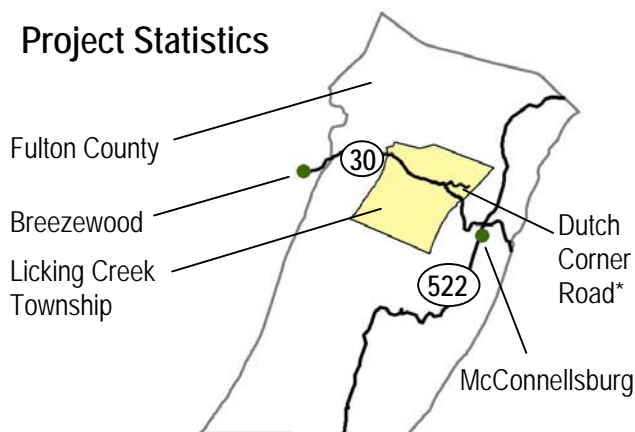
Dutch Corner Road contributed concentrated, sediment-laden water to Patterson Run, a tributary of Licking Creek. Three primary issues caused this impairment: steep road slopes, deeply entrenched road segments, and significant off right-of-way (ROW) water inputs. Long steep road segments bordered by high banks on either side served to trap stormwater water increasing its volume and velocity thus making it highly erosive. Off ROW inputs from driveways and connecting paved roads contributed more water to already concentrated erosive flows.

The deep road entrenchment made raising the road elevation to the height of the surrounding landscape impractical and expensive. The topography lent itself on the steep entrenched road segments to pipe installation through the road banks at a slope of 2% and discharging road drainage on the other side of the bank. Drainage routed in this way is directed into adjacent vegetation where it encounters resistance, can release energy and infiltrate slowly.

**Adding crosspipes and installing pipes through the bank.** 3 existing crosspipes were replaced and 9 new drainage pipes were added. 3 of the 9 were installed through the bank. Increased road drainage capacity minimizes concentrated flow before sufficient volume and velocity can build to strong erosive force.

**Grade breaks and broad-based dips.** On steep driveways at points of concentrated flow, grade breaks and broad-based dips were installed to direct drainage off the driveway surface into surrounding vegetation for infiltration.
